F.S. New Products (A.K.A. Alpine Engineering & Design) engineers have had their hands in hydraulic circuits and components for many years. So, when a client of ours was having some failure problems with the hydraulics on a car lift in their product line, they asked us to help out.

They knew that one of the cartridge valves was failing in the hydraulic circuit. The question was, Why? Technicians at Delta Fluid Power and HydraForce performed failure analyses and came up with differing opinions as to the cause of the failure. Vickers Fluid Analysis Service showed that the hydraulic fluid was contaminated in the failed units, but, was that the problem? At this point the F.S. New Products engineers got involved. The objective was simple:

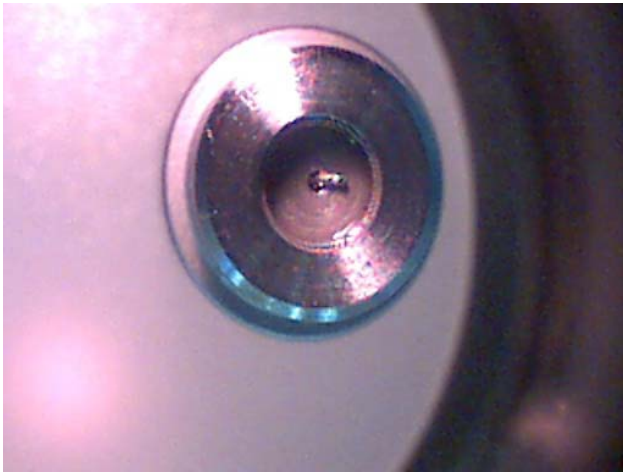
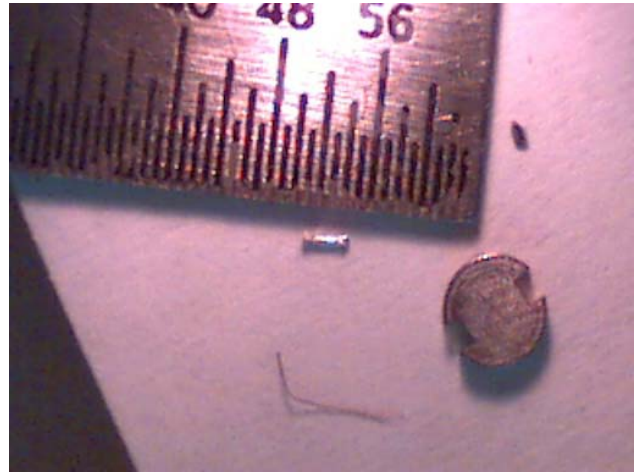
It didn't take much digging to find the problem. All of the valves had failed for the

same reason.

The orifice in the bottom of the poppet on the failed valves was plugged with a non-magnetic wire. We found some other debris in the valves, but the common thread to all the failed valves was the same small wire. We looked at the clogged poppets at 20X, 60X, and even 100X magnification to make sure we hadn't missed anything. The objective was half complete; we knew what caused the failure. The harder question: Where was this small wire coming from?

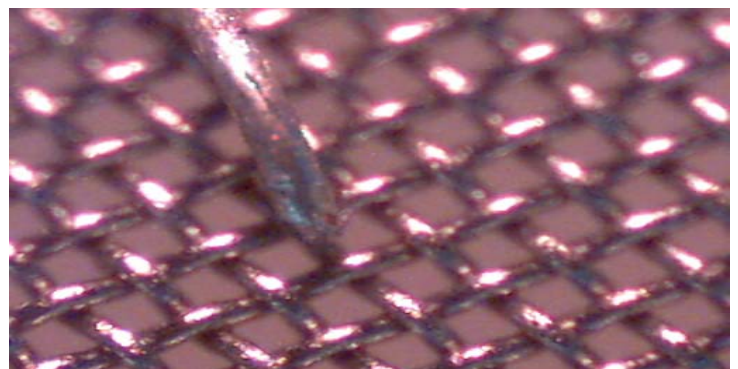
Our engineers began to rule out the possible sources of contamination one by one. Wire reinforcement in the hoses, roll of threads from the valve block, valve screens, suction strainer

screens were all ruled out on the basis of size alone.

Finally, we found it. The support mesh for the screen in the suction strainer matched the size of the small wire contaminate exactly. American West Analytical labs confirmed that it was the same material. A little strainer that costs less than \$10 was bringing the system down.

A new brand of suction strainer and some minor changes to the filtering strategy and the problem was solved.
