F.S. New Products (A.K.A. Alpine Engineering & Design) engineers have had their hands in hydraulic circuits and components for many years. So, when a client of ours was having some failure problems with the hydraulics on a car lift in their product line, they asked us to help out.

They knew that one of the cartridge valves was failing in the hydraulic circuit. The question was, Why? Technicians at Delta Fluid Power and HydraForce performed failure analyses and came up with differing opinions as to the cause of the failure. Vickers Fluid Analysis Service showed that the hydraulic fluid was contaminated in the failed units, but, was that the problem? At this point the F.S. New Products engineers got involved. The objective was simple:

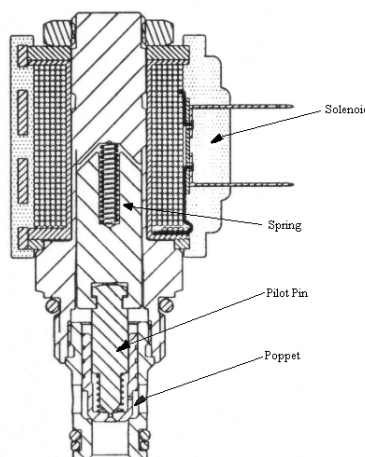
Our first step to identifying the problem is always the same; go to the source. After a quick trip to see the car lift and review the hydraulic circuit, we accumulated a bunch of valves that had failed to begin our investigation.
